R&M DATA ANALYSIS OF THE UH-1/AH-1
TAIL ROTOR SYSTEM

George E. Knudsen, et al

Bell Helicopter Company

April 1974

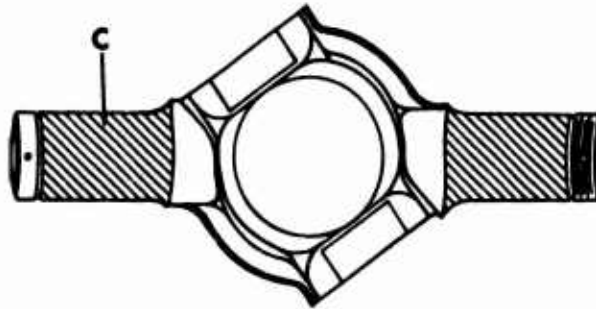
TYPF OF DAMAGE	AREA A	AREA B	AREA C
NICKS, SCRATCHES, SHARP DENTS	0.005 inch Max. Depth	0.010 inch Max. Depth	Refer to Wear Limits Charts
CORROSION	0.002 inch Max. Depth	0.005 inch Max. Depth

- Prior to attempting installation of the roll pins, it is mandatory that positive alignment be established to insure damage free assembly.
- Scratches in trunnion housing bore may be polished out if less than 0.002 inch in depth.

Figure 22. Tail Rotor Hub Yoke Damage Limits (P/N 204-011-701), Model UH-1C.
